## THE CONSERVATION APPROACH

*Asgard* is a 51-foot (15.5-metre) wooden yacht, designed and built by Colin Archer in Norway in 1905. Today, she provides an excellent example of the technique of conservation. The National Museum of Ireland, following a decade of debate, made the decision to adopt a conservation approach and place her on static display indoors, by preserving her original materials as far as possible.

# THE CONSERVATION PROJECT

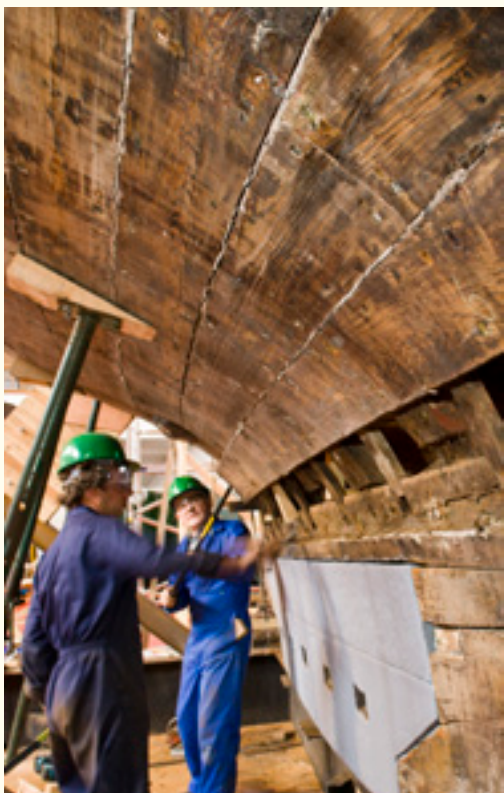
Ar chlé: Planc cabhlach á bhaint.

Left: Removing a hull plank.

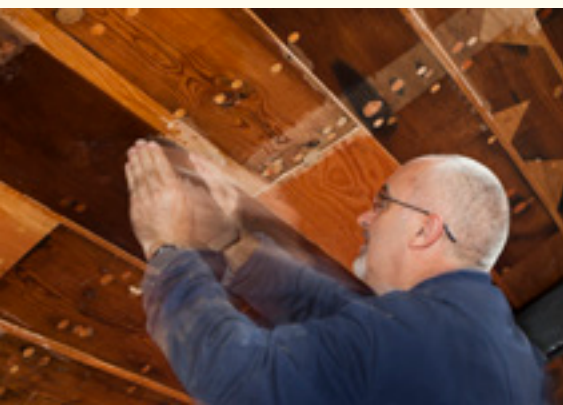
Ar chlé: Deasbhord na cabhlach: áit chun cothromaithe a bhí clúdaithe roimhe seo ag seac tacaíochta cabhlach.

Left: Starboard hull: fairing area previously covered with a hull support chock.

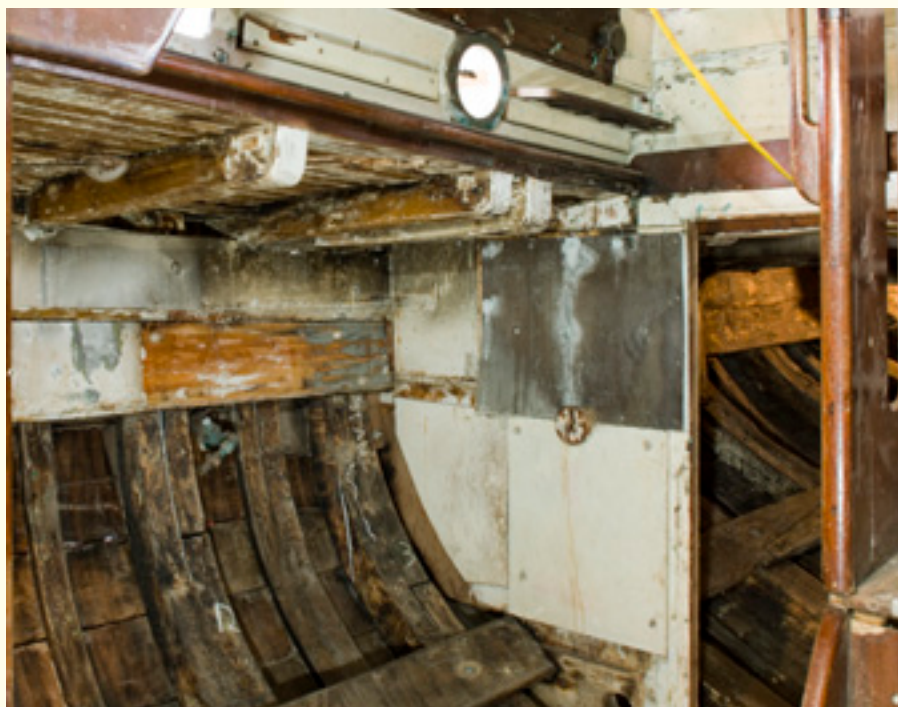
Ar barr, ar dheis: Radharc ar *Asgard* sular caomhnaíodh é: an taobh istigh, lár báid, clébhord.

Top Left: View of *Asgard* before conservation: interior, amidships, port side.

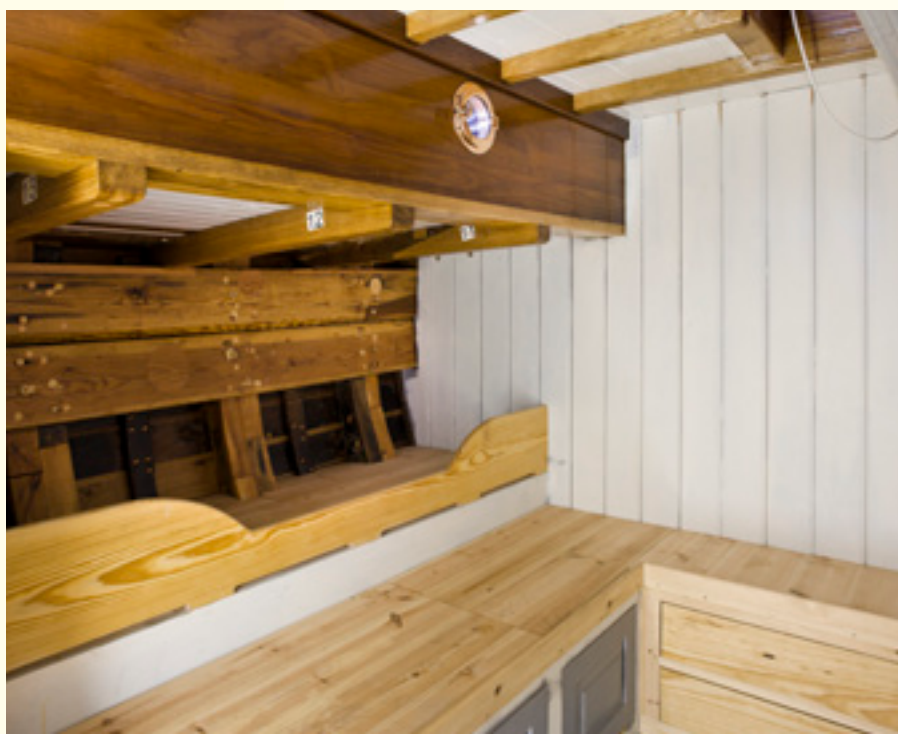
Ar bun, ar dheis: 'Cábán an úinéara' (cábán Childers), struchtúr an chlébhoird críochnaithe agus an phéinteáil ar siúl.

Bottom Left: 'Owner's cabin' (Childers's), port side, structurally complete, with painting in progress.

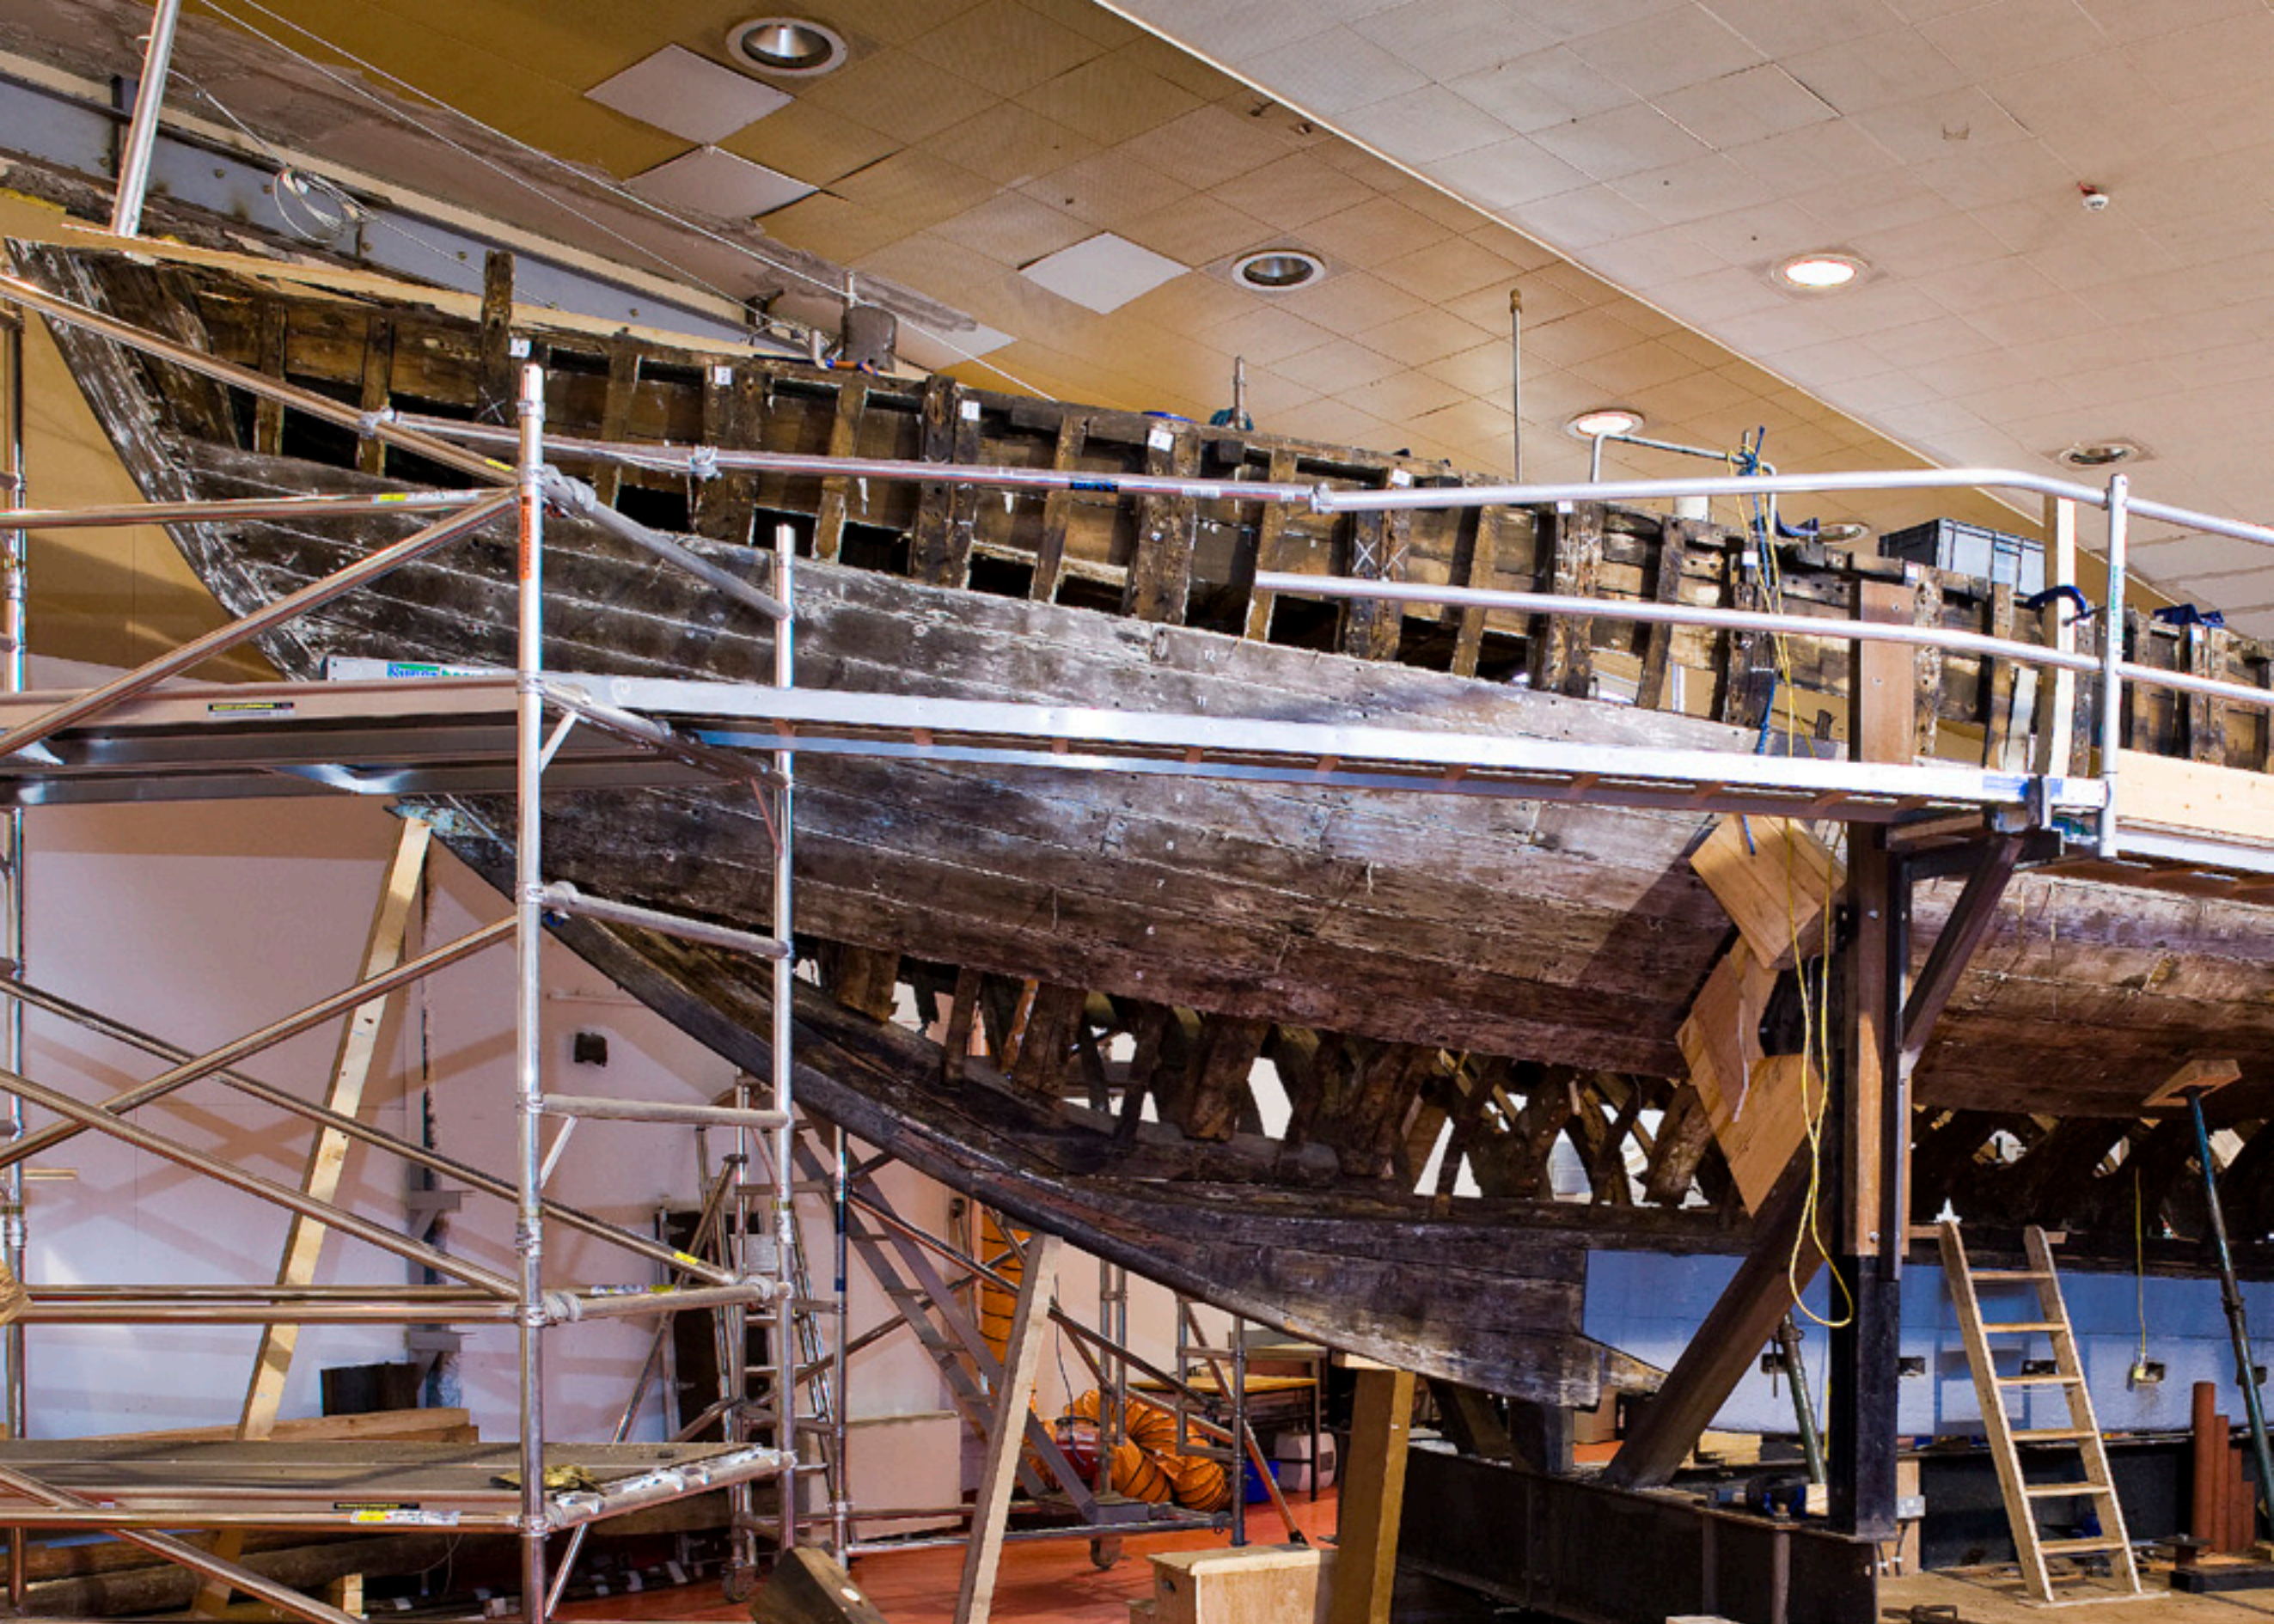
Ar chlé: Radharc ar an gclébhord ina bhfeictear an fho-chabhail agus an áit ar baineadh an phlainceáil uachtarach lena cóireáil.

Left: View of port side with lower underbody and top side planking removed for treatment.

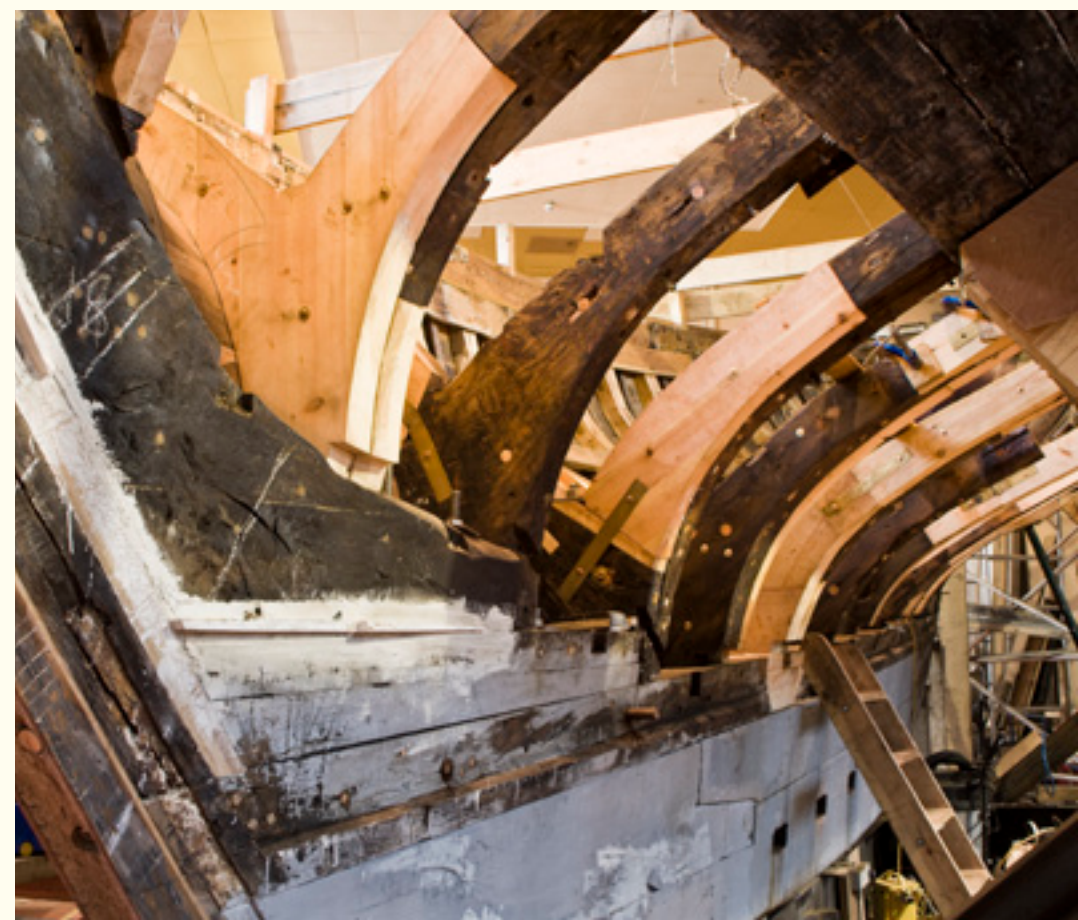
Ar dheis: An ceathrú íochtarach thiar, radharc ón deasbhord, ag taispeáint an phosta dheiridh / an stoic stiúrtha, broсна agus an ghlúin thiar, agus cóireáil a déanamh ar fhrámaí an deasbhoid.

Right: After lower quarter, starboard view, showing sternpost / rudderstock, deadwood and after knee, with treatment of starboard frames underway.
