## THE CONSERVATION APPROACH

*Asgard* is a 51-foot (15.5-metre) wooden yacht, designed and built by Colin Archer in Norway in 1905. Today, she provides an excellent example of the technique of conservation. The National Museum of Ireland, following a decade of debate, made the decision to adopt a conservation approach and place her on static display indoors, by preserving her original materials as far as possible.

# THE CONSERVATION PROJECT

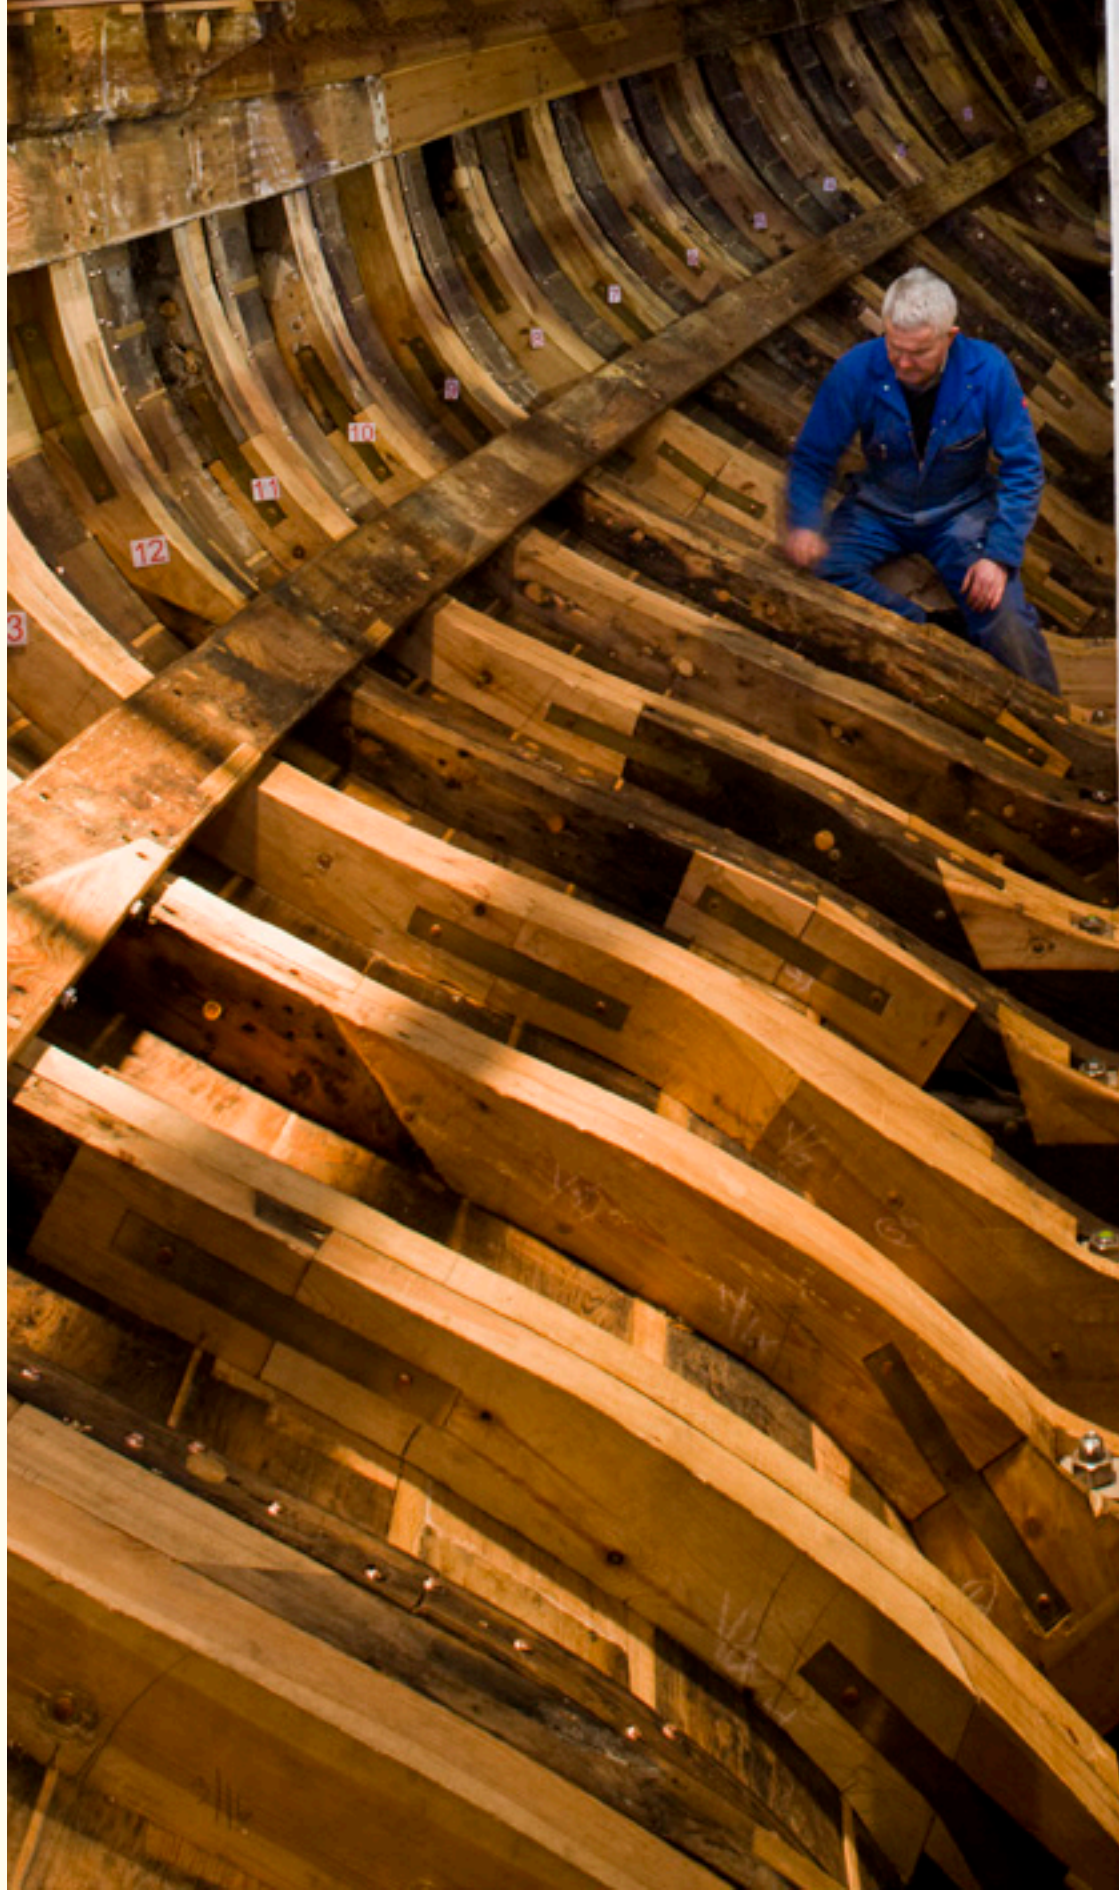
Ar barr, ar dheis: Radharc ar *Asgard* sular caomhnaíodh é: an taobh istigh, lár báid, clébhord.

Top Left: View of *Asgard* before conservation: interior, amidships, port side.

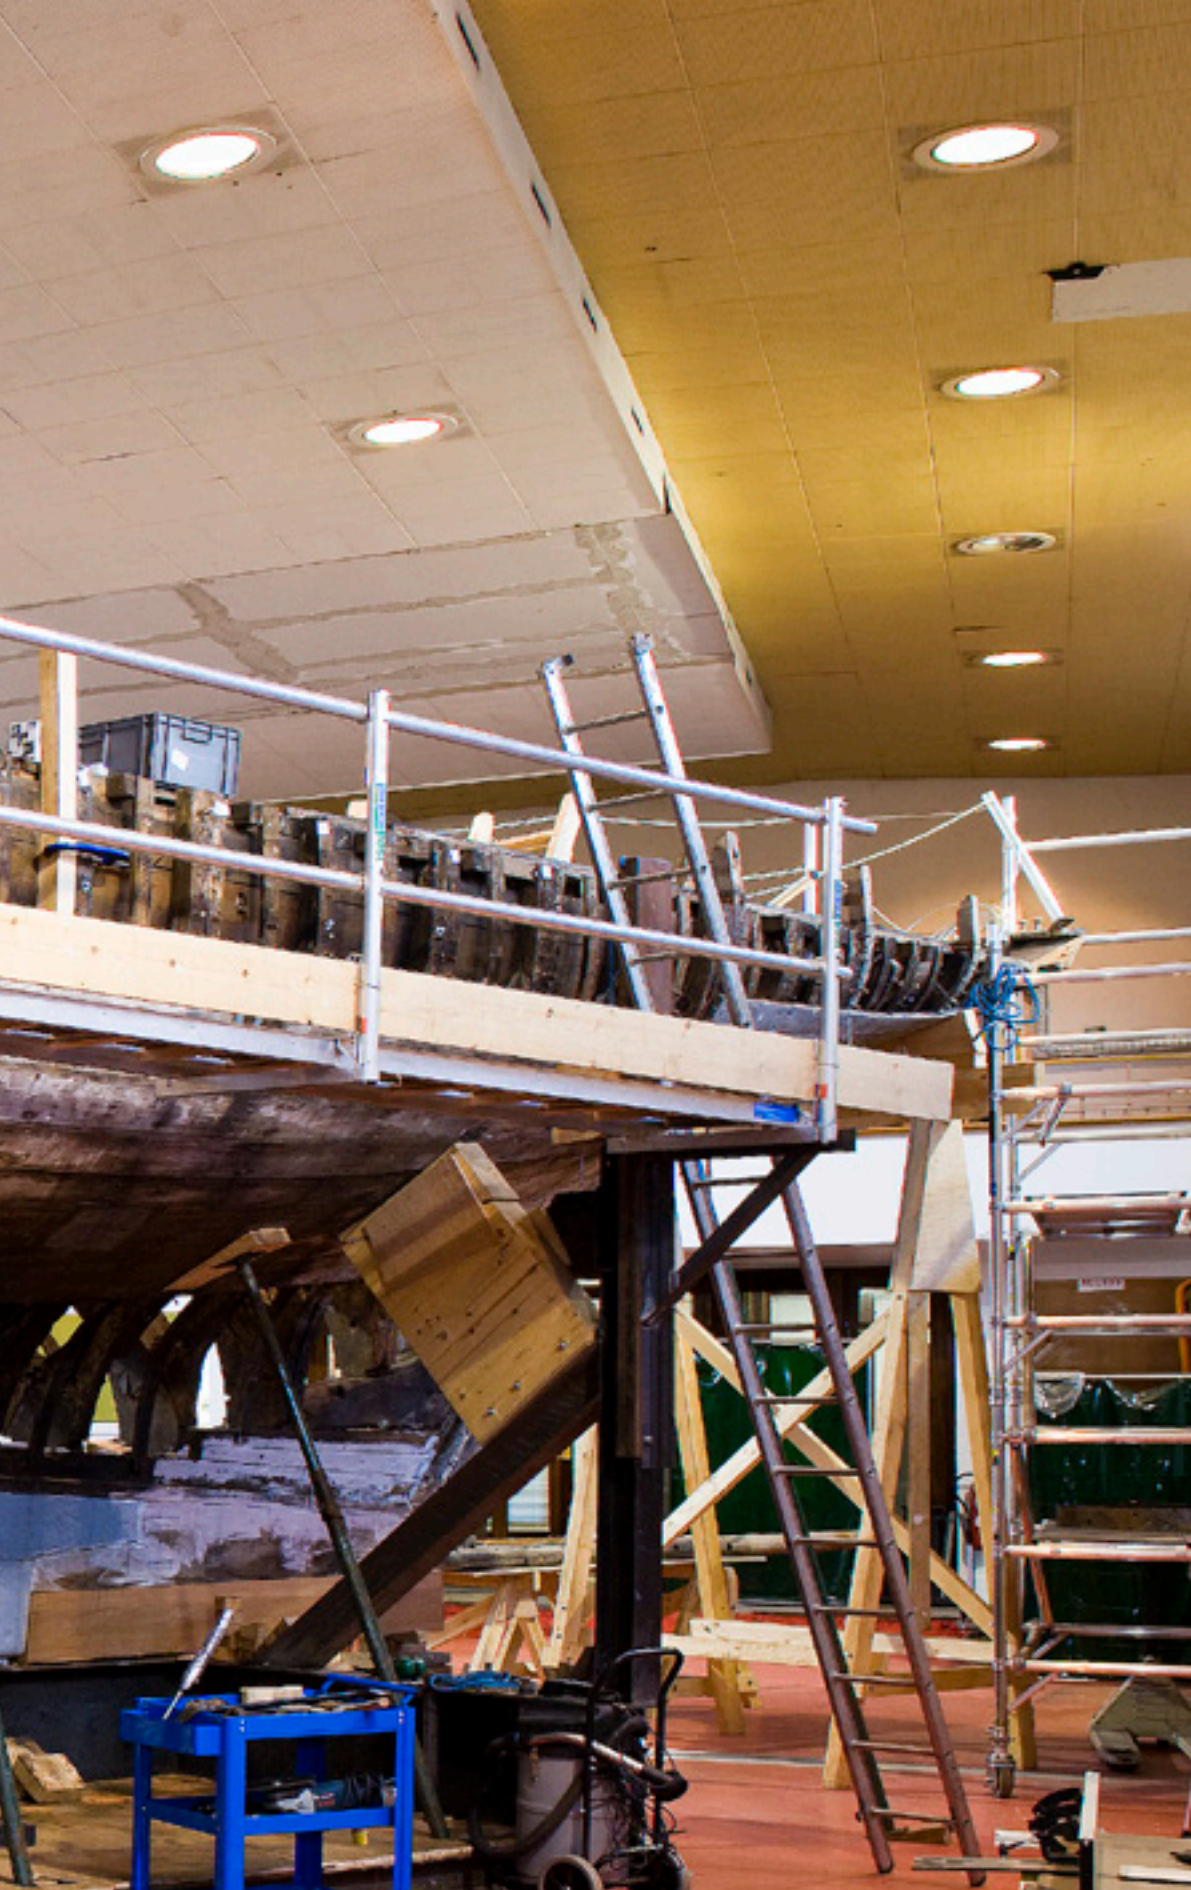
Ar chlé: Radharc ar an gclébhord ina bhfeictear an fho-chabhail agus an áit ar baineadh an phlainceáil uachtarach lena cóireáil.
